TECHNICAL REFERENCE

The restoration of the leaning Tower of Pisa

Pisa, Italy

Under-excavation
Reinforcement

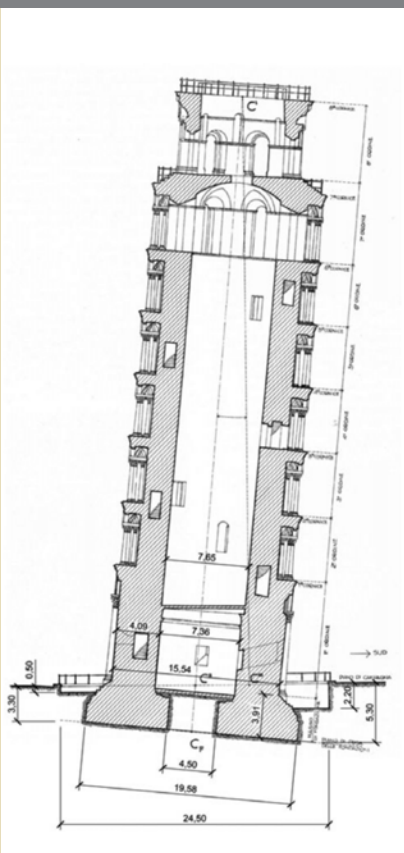
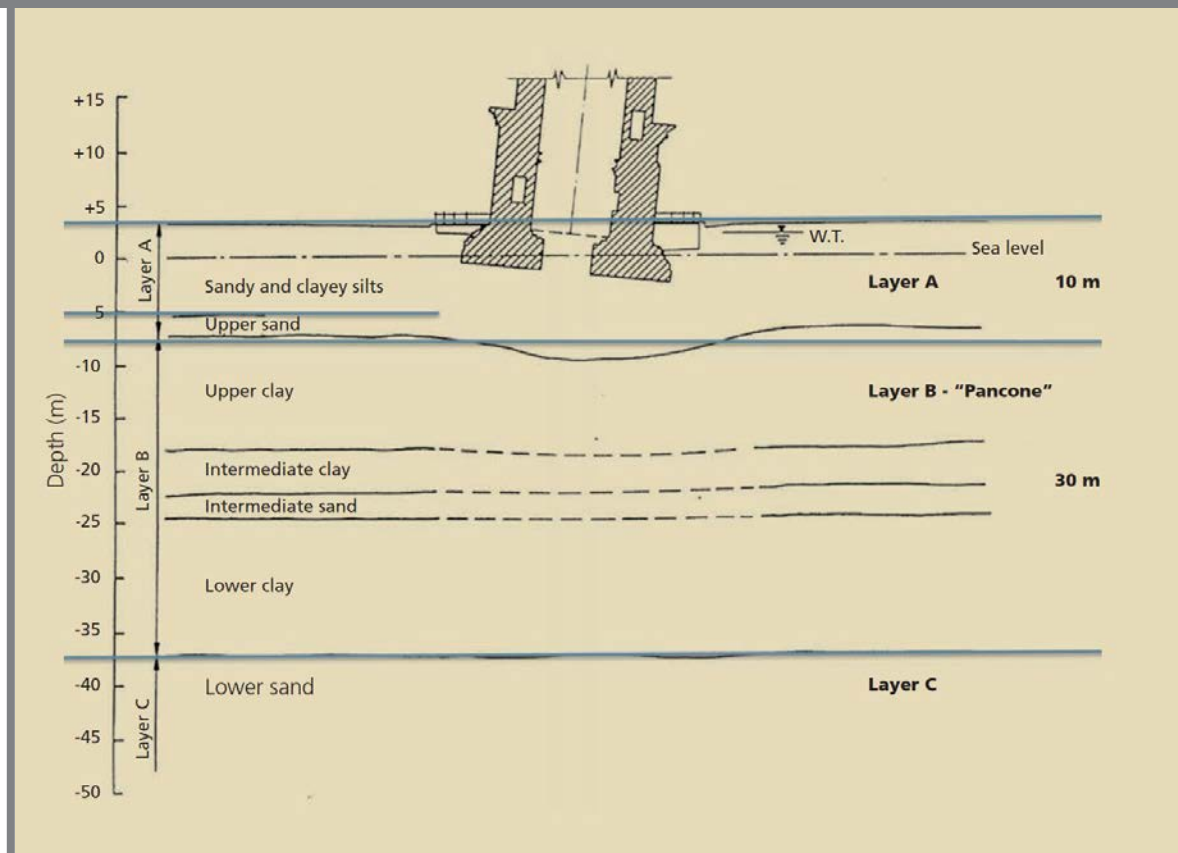
Change of the Tower's inclination over time

From 1911 onwards inclination grew significantly and constantly with two abrupt major accelerations: in 1935,

At the beginning of its building the tower leaned towards North and reached a **maximum inclination of about 0.2° in 1272 when the building was resumed after the first long stop.** In 1278, when the seventh cornice was built, inclination was about 0.6° South.

During the ninety-year stop inclination increased and by the time the bell-chamber was built it had reached 1.6°.

as a result of a campaign of injections into the foundation aimed at stopping water from infiltrating the Catino, and later on in the mid-60s, because of an intensification in the pumping of water from the lower underground sands because of particularly dry, low rain seasons.

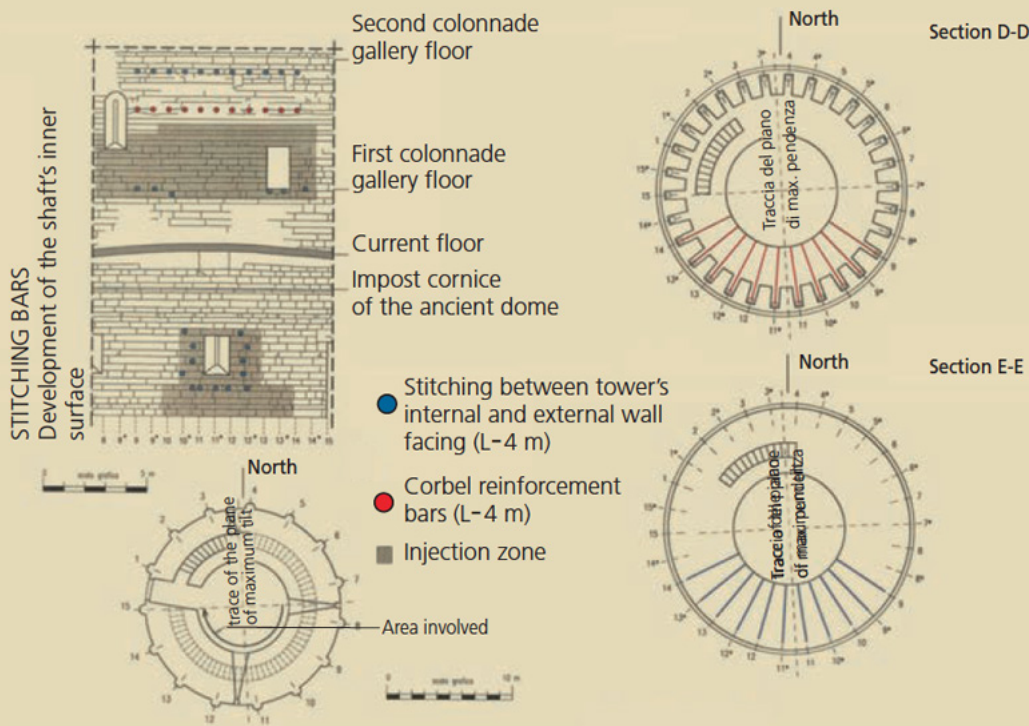
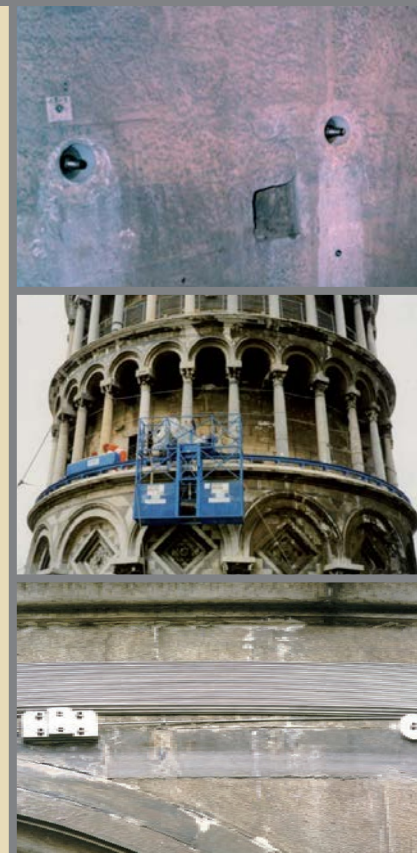
New reinforcement rings

In order to integrate the containment effect provided by the radial stitching of the masonry in the most critical area (which corresponded to the areas of abrupt narrowing of the walls in the point of transition between the first and the second order) the Committee decided that after removing the temporary rings these rings should be at least partly replaced by other rings with aesthetic and functional features that made them suitable for permanent use.

The new reinforcement rings replaced the temporary ones (8-strand for those below the 1st order cornice and 4-strand for those at the base of the 1st loggia; while no reinforcement ring was required to replace the 6 upper strands).

The final and permanent rings were made with 4mm diameter stainless cold-drawn steel wire; cold-drawn wire was chosen as it further increased the wire's mechanical features bringing
