Installation of the innovative battery-powered water system at the Calypso Club

Report by Dr. Giovanni Barbieri, Director of Calypso Life S.r.l.,
Bibbiano (Reggio Emilia)

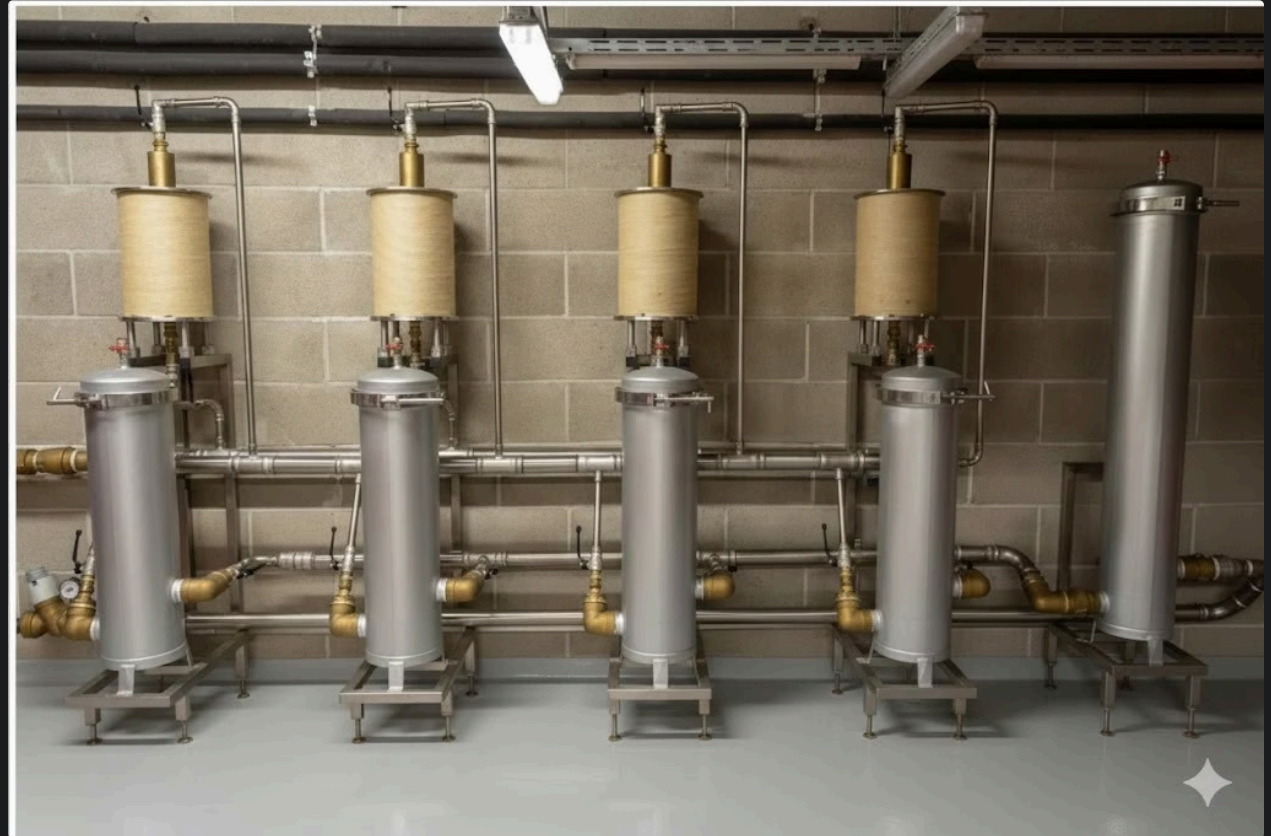
With the installation of the new battery regeneration system, the use of the water softening system was eliminated. The system immediately provided the correct pressure and no problems occurred in the normal operation of the services.

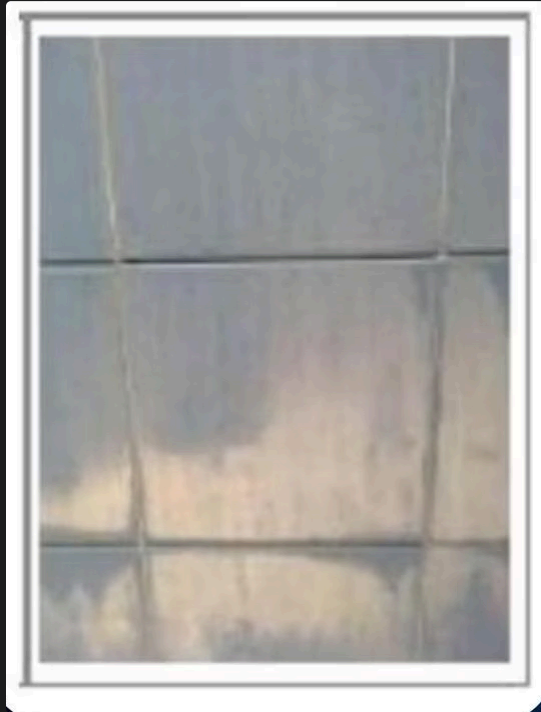
Before

Limescale Deposits

Daily and visible deposits

Limescale deposits on the shower tiles have significantly decreased, reducing ordinary cleaning effort. Since installation, maintenance of buttons and nozzles has been suspended without any issues with shower functionality.

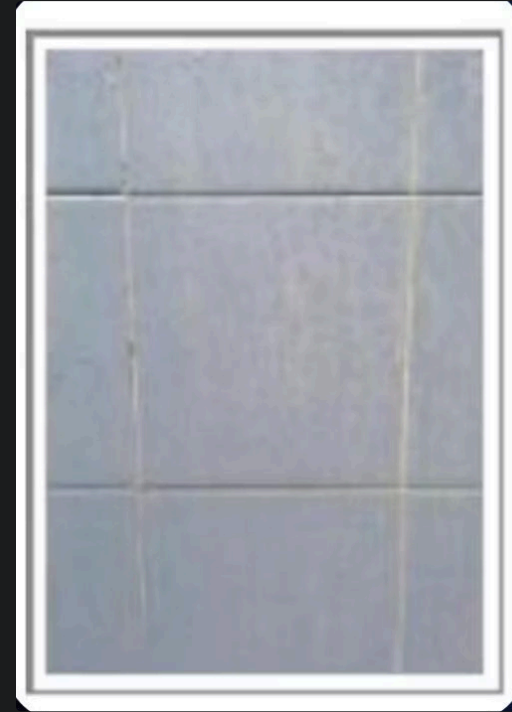
After

Drastic reduction in deposits

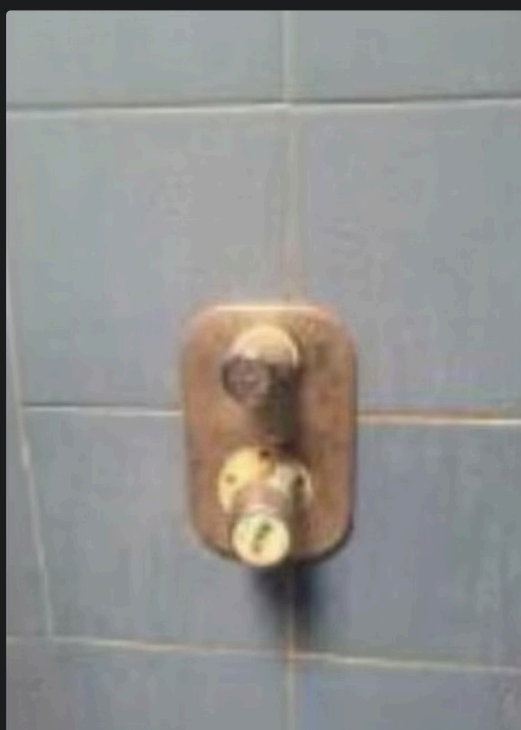
Before

Shower Functionality

Mandatory quarterly maintenance

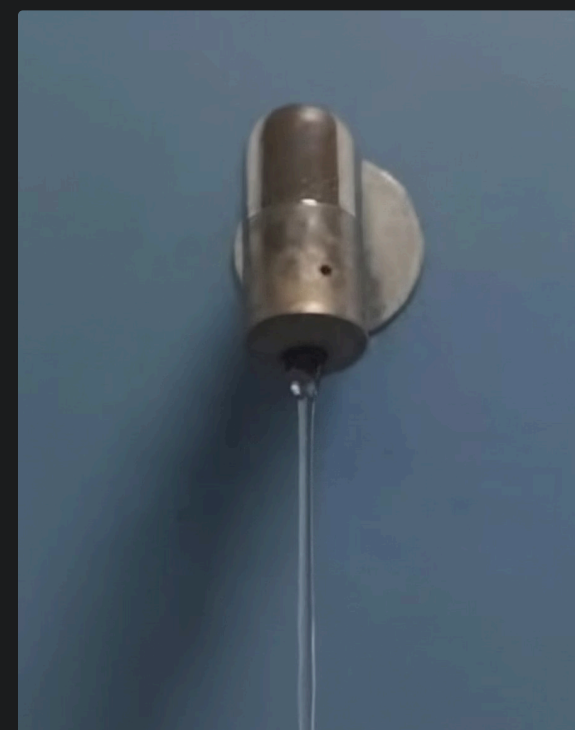
After

Maintenance suspended without issues

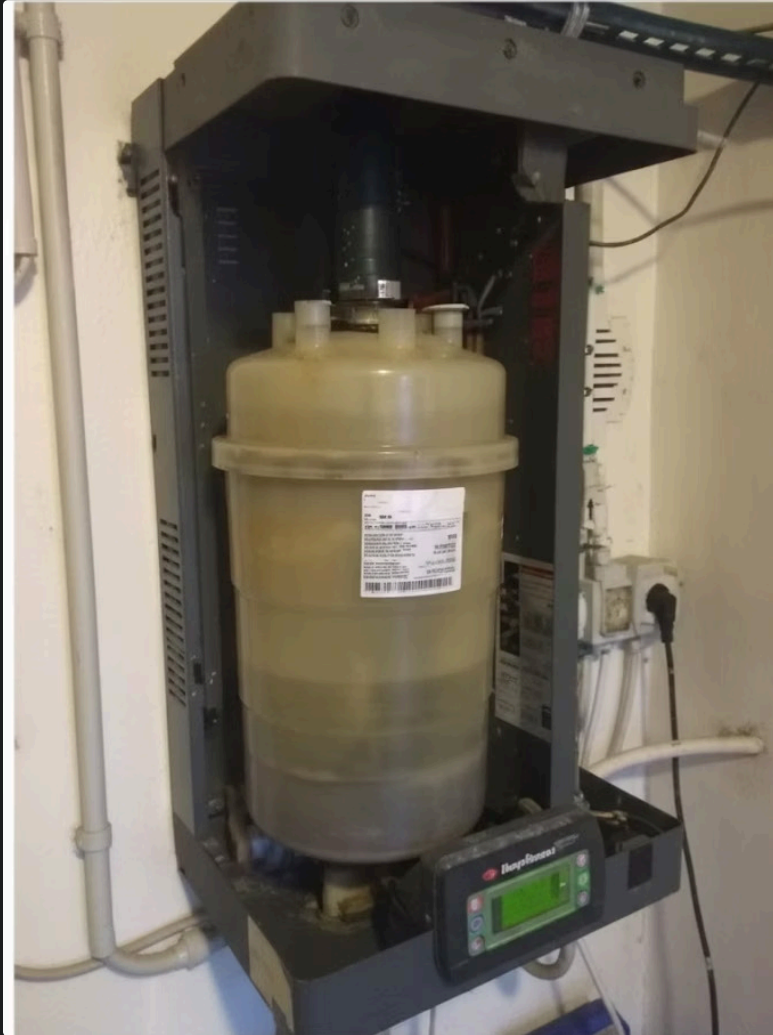
Turkish Bath (Steam Generator): No Limescale

Since the last maintenance of the Turkish bath steam generator, and after **10 months of use**, the generator shows no signs of limescale.

Consequently, maintenance has been postponed, resulting in significant time and cost savings.
