FOUNTAIN ARDEA PURPUREA

VERDUN, BEIRUT

PROJECT DOSSIER:

*Fountain Removal, Restoration,
Installation, and Parallel Activities*

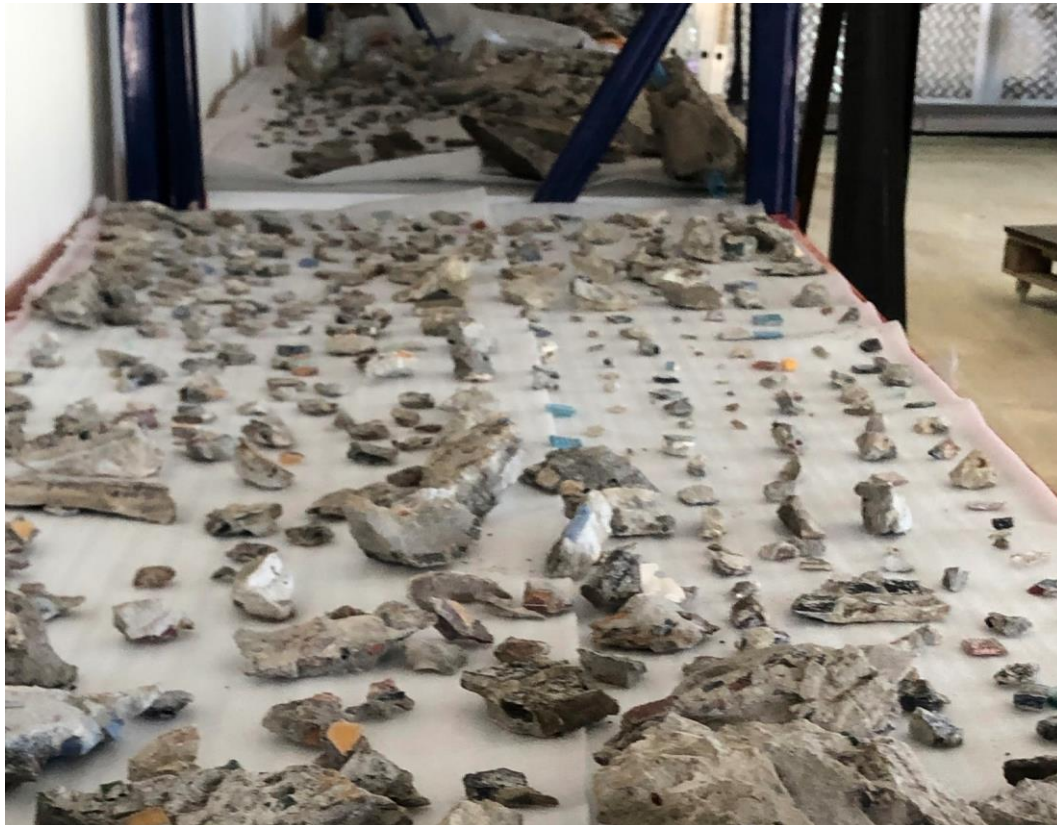
The initial stages of the restoration, carried out by Selim Germanos from the DGA in July 2024, focused on conducting comprehensive surveys and a detailed visual assessment of the fountain's condition. The process began with a metric survey to obtain accurate measurements of the fountain, which were crucial for fully understanding its dimensions and spatial relationships, particularly as the artifact was to be relocated for restoration. A variety of technologies were used to gather an extensive set of precise data, which supports the project's development throughout the restoration process.

The result was a cloud of points generated through photogrammetry, which not only informs the current decay analysis, restoration and design efforts but also will serve as an important reference for future maintenance interventions and typological documentation.

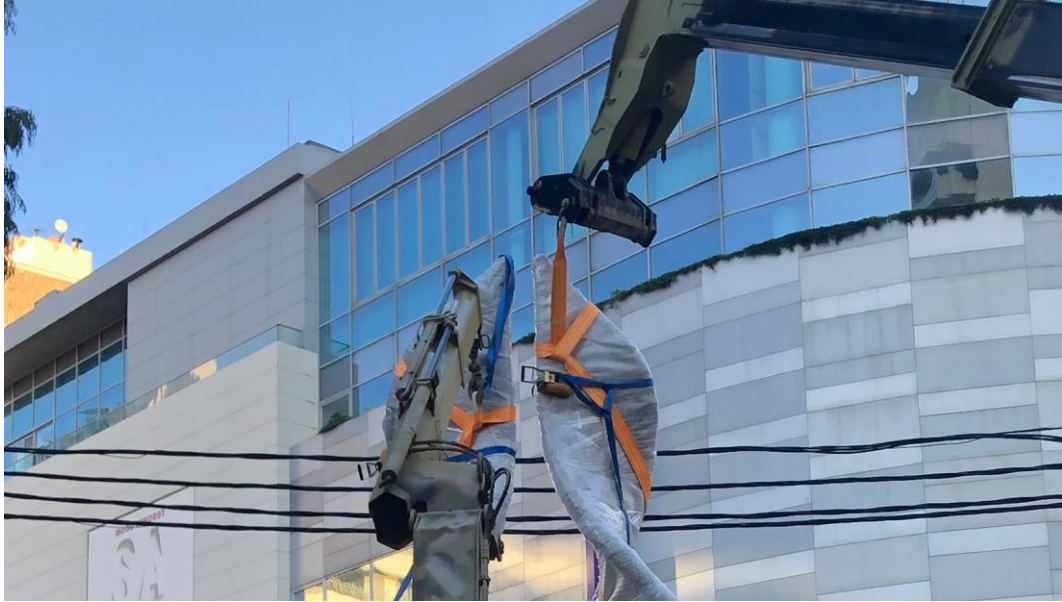
In July, the preliminary discussions included the planning of pre-consolidation and stabilization measures aimed at providing temporary stability to the most deteriorated areas, where more invasive interventions would be required later. This phase would involve the application of a veiling layer of fabric or specialized mesh, which would support the mosaic during the conservation process, particularly in areas showing signs of detachment between components.

Following the agreements made in July, during the execution phase, the preparation process focused on ensuring the artifact was properly prepared for transport to minimize any risk of damage. This was achieved by using sponge pads and applying a shock-absorbing coating to the entire structure.

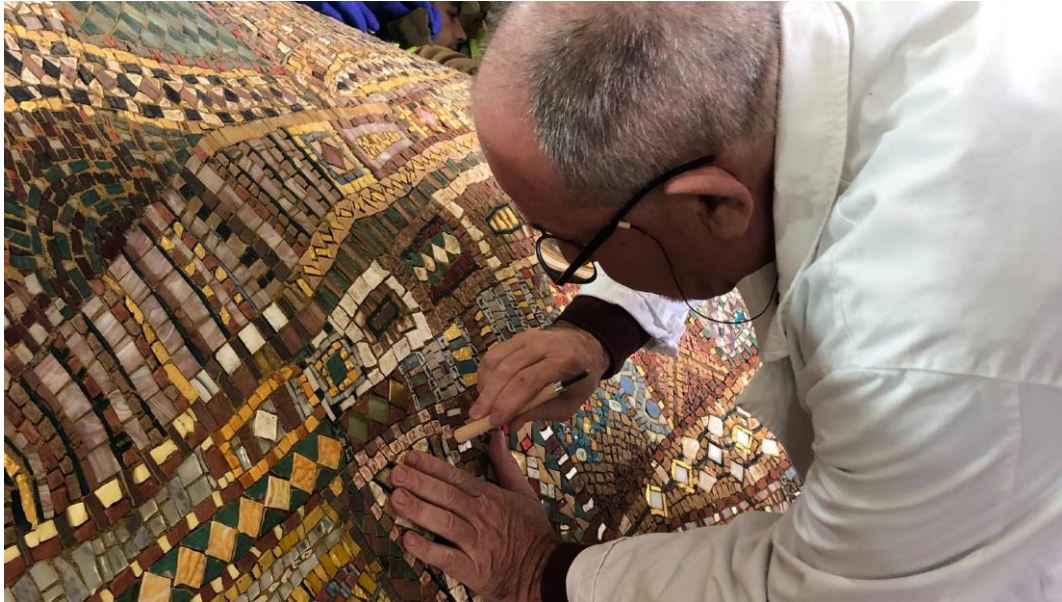
Although in July it was suggested to investigate and assess the internal conditions of the structure and materials using core drilling to check for potential water infiltration, this method has been deemed unnecessary after a detailed examination of the structure off-site.

In fact, during the tactile and visual inspection conducted in January by restorer Carlo Chinellato, no signs of water infiltration were observed. The fiberglass structure appeared to be intact, showing only slight rust stains at the base and faint traces of calcareous deposits.

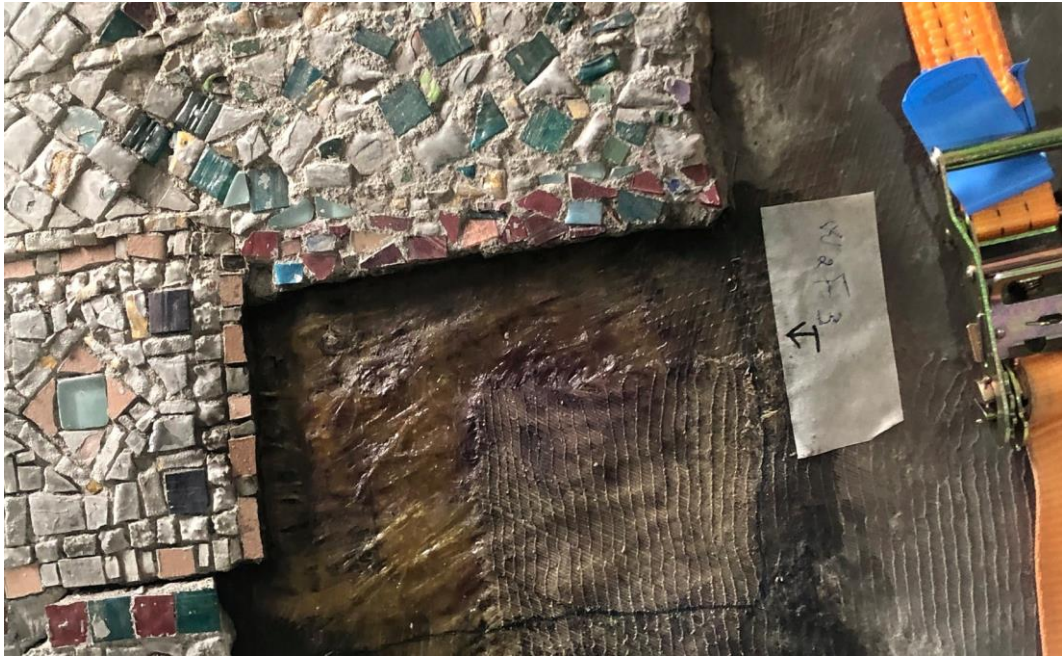
In January, a thorough visual, percussive, and tactile investigation was carried out across the entire surface, which revealed that the condition of the areas still attached to the support was generally good. However, some detached sections were found to need cortical consolidation, which will involve the injection of consolidating products such as epoxy resin, to be performed under the supervision of specialized restorers.

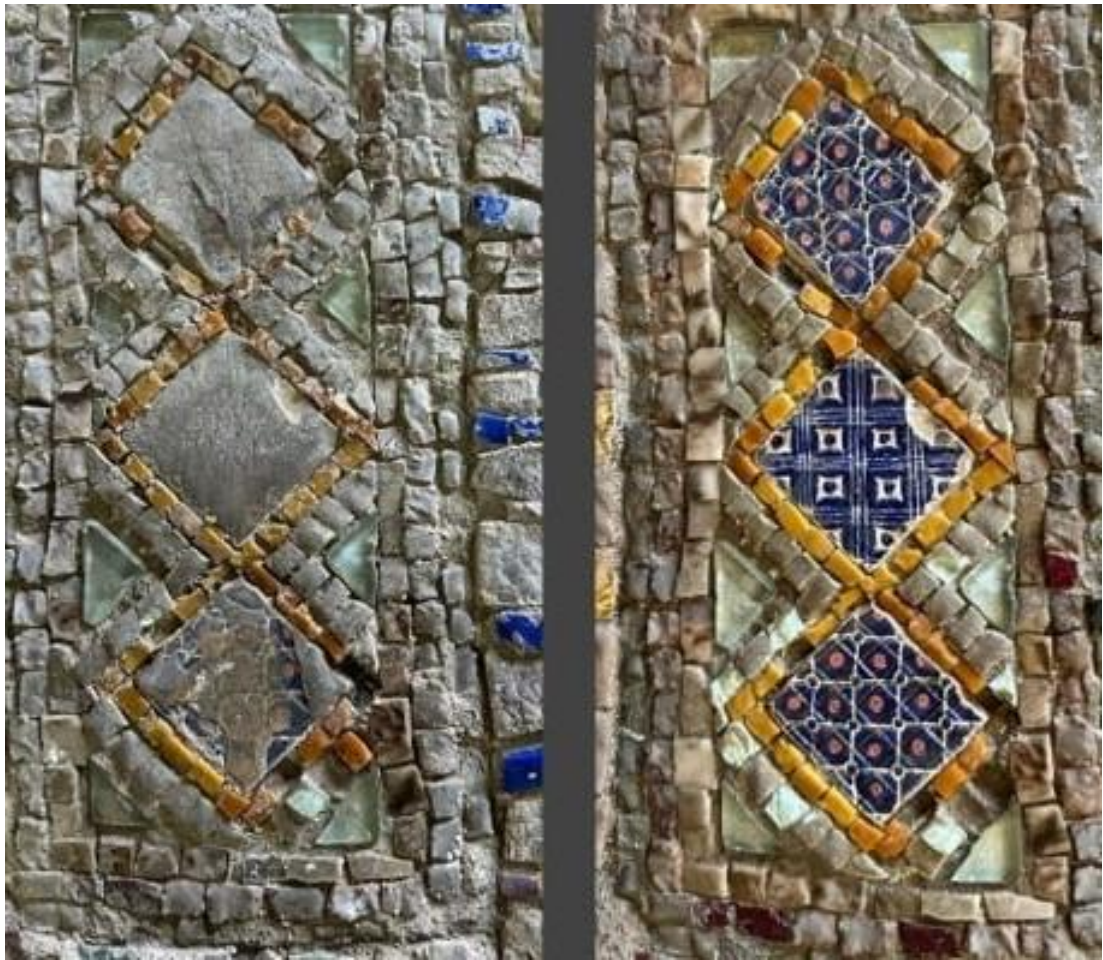
During the execution phase, preliminary tests were carried out using products such as Kerabonf T with Isoelastic additive (Mapei) and Mur Ex filler (Toupret) to determine the best methodology for reattaching medium and large detached mosaic portions to the support.

The artist Marco Bravura supplied redesigned sections of the mosaic as previously discussed. Furthermore, it is important to note that

between July and January, the condition of the mosaic deteriorated, with additional sections detaching, and the portion at the base of the two components was dismantled, as described earlier. Given these circumstances, it was agreed that Marco Bravura would personally manage the final stages of the reconstruction, producing extra sections to be integrated into the artwork, ensuring alignment with the updated design and anchoring techniques.

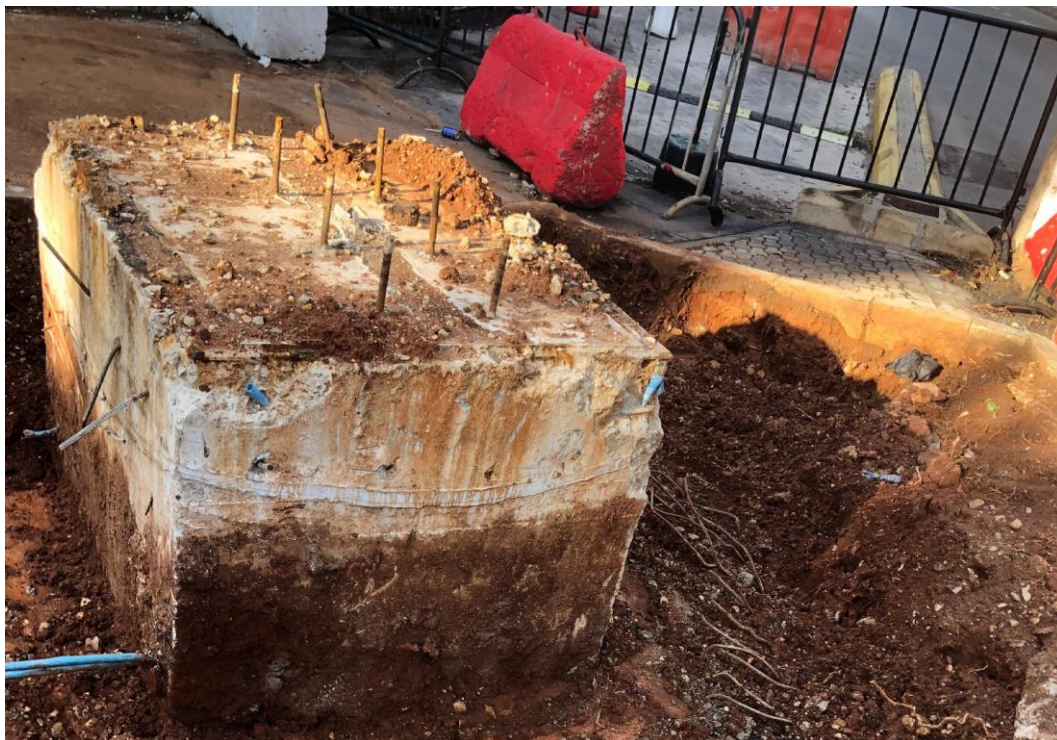
After the sculpture was removed and the basin dismantling and cleaning of the project site were completed, the pipes were identified and inspected. As agreed upon with the artist and all parties involved in the reconstruction and requalification, the pipes will be repositioned to direct water to lateral jets within the basin, while the central jets will be eliminated. This adjustment will improve future maintenance by reducing issues related to rising moisture and calcium deposits. Additionally, a comprehensive survey of all pits and control systems associated with the fountain has been conducted and assessed in collaboration with Rockland Group, which will oversee the construction phase under the supervision of Architect Francesca Brancaccio.

To support this operation, it is worth noting the precedent of the Ravenna fountain, where severe damage occurred due to thick ice, which was caused by the lack of a seasonal maintenance program for the hydraulic systems and the failure to drain the basins during the winter months. The redesign of the basin provides an opportunity to resolve these issues by enhancing the hydraulic system and establishing a more efficient control and maintenance scheduling program.
